## **CAUSES OF ENGINE BEARING FAILURE**

The aim of this manual is to enable the reader to diagnose the causes of engine bearing failure through visual inspection of the bearings. Depending upon the type of failure detected, recommendations are then given as to how to remedy the specific cause of damage. One has to keep in mind here that, in addition to ascertaining the appearance of damaged bearings, accurate diagnosis will necessarily call for further information both on the other components involved and on the precise operating conditions. A summary of the most common causes of bearing failure is provided below, although some failures will inevitably result from a combination of more than one cause.

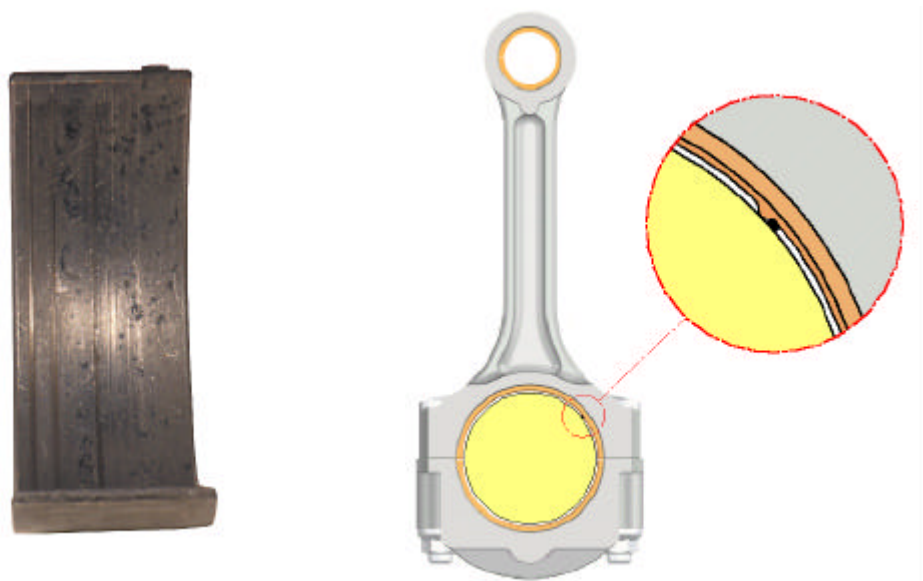
### **DIRT IN THE LUBRICATION SYSTEM**

The presence of dirt particles entrained in the lubrication system is one of the most frequent causes of bearing damage. The root of the problem is usually that the engine is not sufficiently clean. In line with the nature and size of the foreign particles, the bearing will exhibit a correspondingly lesser or greater degree of circumferential scratching and, usually, any debris that may have become embedded in the lining.

**Recommendation:** when repairing the engine, ensure that the entire lubrication system is carefully cleaned

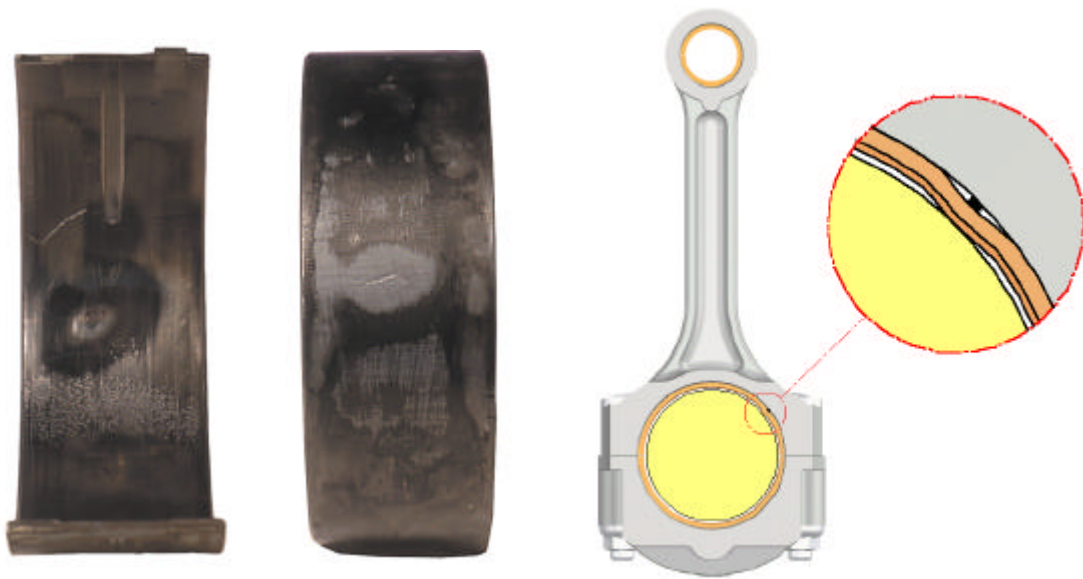
### DIRT ON BEARING BACK

The presence of a foreign particle trapped between the bearing back and its housing will lead to a raised area, with the ensuing risk of contact between this protruding high-spot and the journal. Signs of this will be seen in the area opposite the particle, along the inner surface of the bearing, where there will be evidence of marked localized wear.

**Recommendation:** ensure that all housings in which bearings are to be seated, are carefully cleaned prior to assembly.

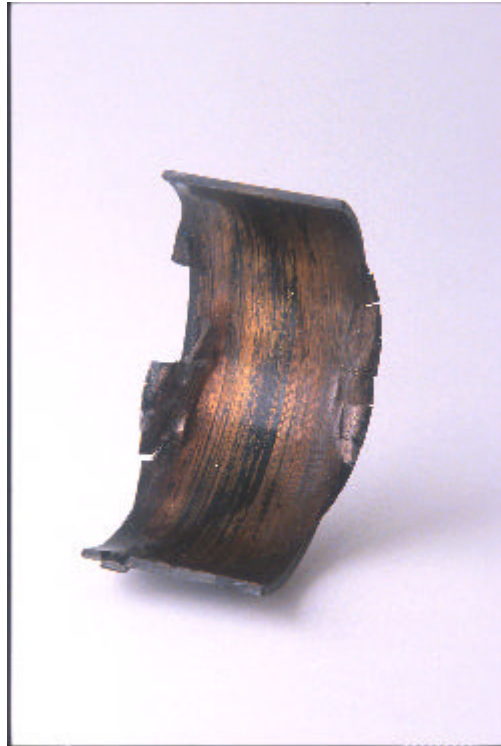
### **MALFUNCTION IN THE LUBRICATION SYSTEM**

A total absence of lubrication of the journal-bearing system leads to bearing seizure and, normally, to total destruction of the part. However an altogether more frequent phenomenon is fatigue due to oil starvation, whereby the amount of oil reaching the journal-bearing system is insufficient to maintain the oil film, leading to metal-to-metal contact between the two parts. Prolonged operation under such conditions will also result in total destruction of the whole.

**Recommendation:** the lubrication system must be thoroughly checked in order to pinpoint the cause of failure, which may be a blocked oil passage, an improperly installed bearing, an oil pump malfunction, etc.

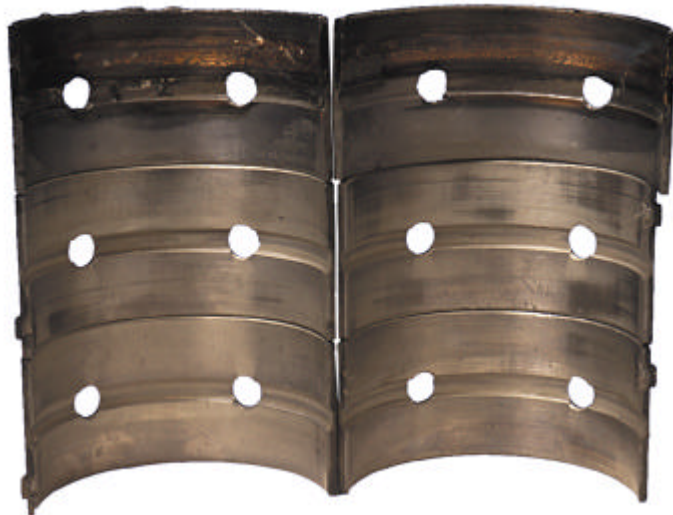
### **OIL SEAL FAILURE**

In the example shown in the photograph, the failure of the crankshaft seal led to oil escaping at this point. The track of the pair of bearing shells nearest the seal exhibits symptoms of seizure, due to the oil film rupturing as a result of loss of oil pressure. The circumferential oil groove acted as a barrier to the defect, so that the other track of the bearing shells, as well as the two remaining pairs in the set, only exhibit shiny areas, a sign of oil starvation.

**Recommendation:** check for possible loss of oil at the seals and replace these wherever necessary.

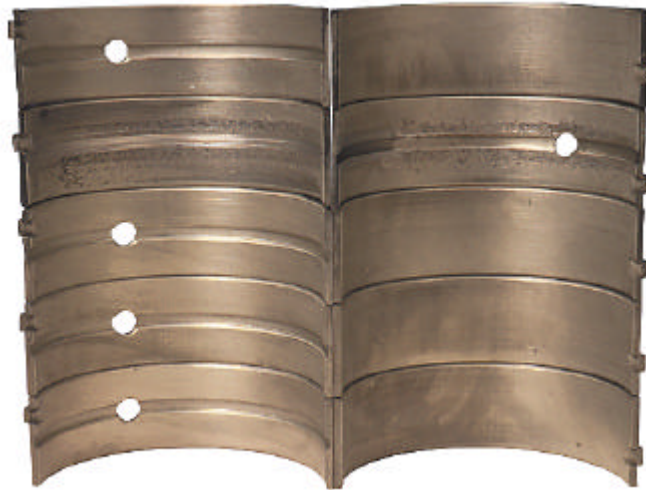
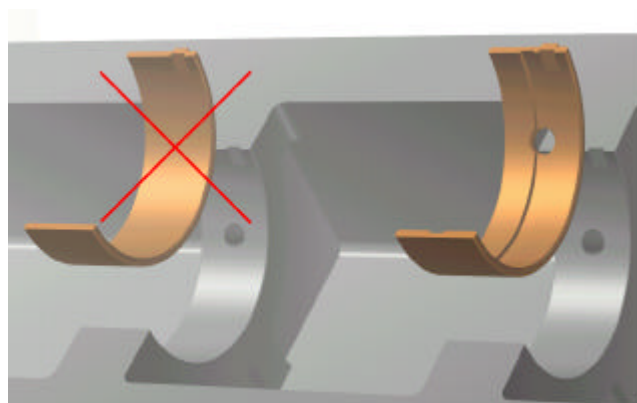
#### **BEARING REVERSED**

Where a bearing having no oil hole is mistakenly fitted in a position in which it ought to have one, e.g., in a case where the upper and lower seats of a pair of main bearing shells are inadvertently switched, this effectively prevents that particular main journal receiving lubrication. As a consequence, no lubrication can reach the crankpin via such oil holes, eventually leading to seizure of the bearing in question. From the bearing back, it will be evident that the oil passage hole has been blocked off.

**Recommendation:** ensure that the utmost precaution is taken during the installation of new bearings and that the correct positioning of each is double-checked

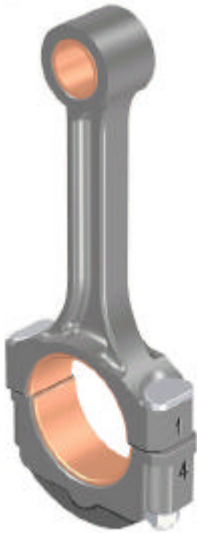
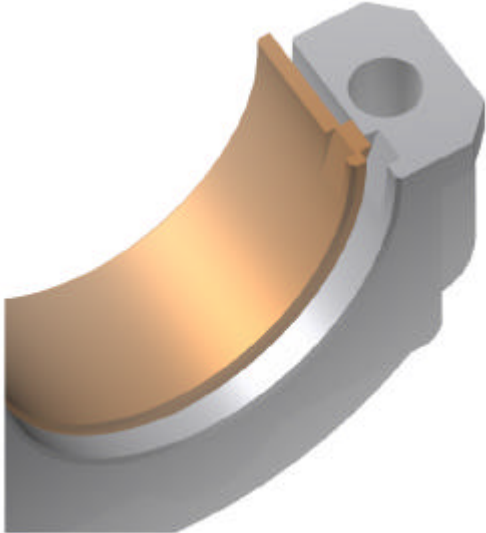
REVERSED CON-ROD OR BEARING CAPS	LOCATING LUGS NOT NESTED

When engines are being repaired, the following assembly errors tend to occur fairly often. There will be areas where lubrication may be insufficient, with evidence of excessive localized wear.

**Recommendation:** ensure that each and every engine component is correctly installed.

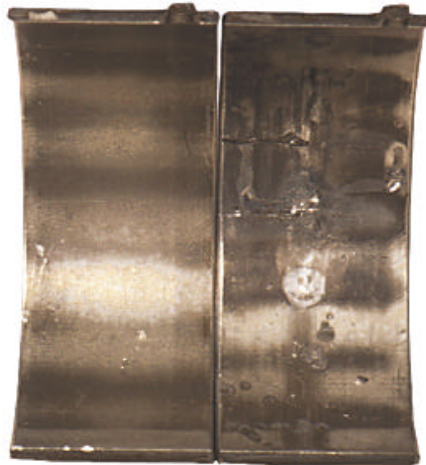
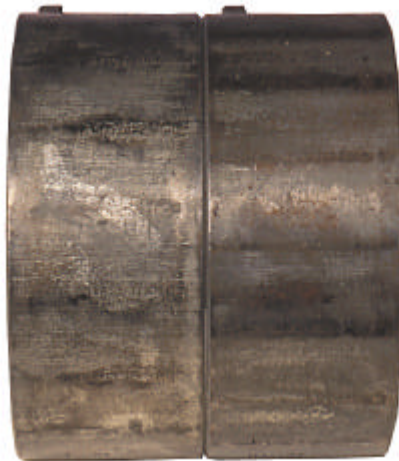
##### **IMPROPERLY GROUND HOUSING (FACETED OR POLYGONAL)**

Where a housing bore becomes flawed due to engine vibration or some other cause that gives rise to marked out-of-roundness, the bearing will tend to conform to the defective shape of its housing. It will display alternating bands of heavy and normal wear. This defect can lead to metal fatigue.

**Recommendation:** check for correct grinding of shaft and housing

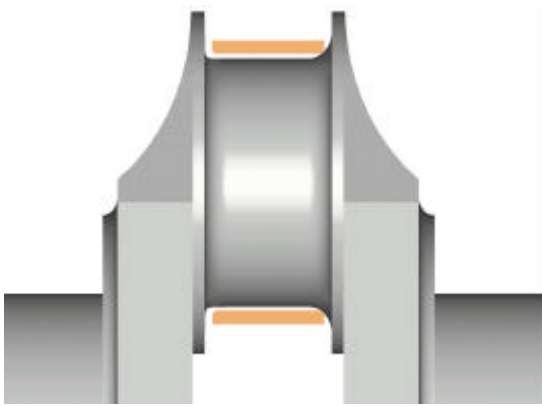
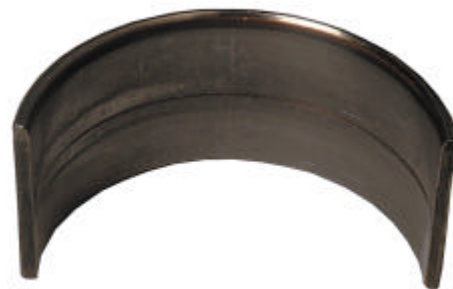
##### **FILLET RIDE**

If the radius of the fillet is increased during the course of a repair to the crankpin, the edge of the bearing may make metal-to-metal contact with the fillet, and will also hinder oil flow. In the photograph, the bearing exhibits signs of incipient damage, with its edge rounded from rubbing against the fillet.

**Recommendation:** use a grindstone in perfect condition to achieve correct crankshaft geometry

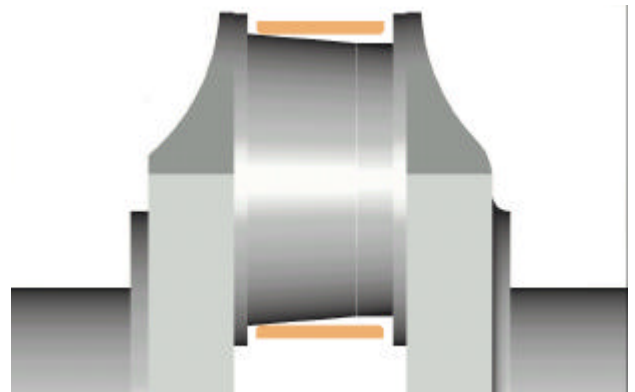
##### **OUT-OF-SHAPE JOURNAL: HOUR-GLASS SHAPED, BARREL SHAPED OR TAPERED**

If the grindstone suffers from excessive wear, the crankshaft will conform to its errors of shape. This means that the clearances and, by extension, the load distribution will not be the same throughout the bearing surface, thereby accelerating bearing wear in the most highly loaded regions due to uneven and inadequate lubrication. Journals can be found with areas that are partially hour-glass shaped, barrel shaped or tapered. Visible in the figure is a damaged bearing that has been mounted on a partially tapered journal.

**Recommendation:** use a grindstone in perfect condition to achieve correct crankshaft geometry

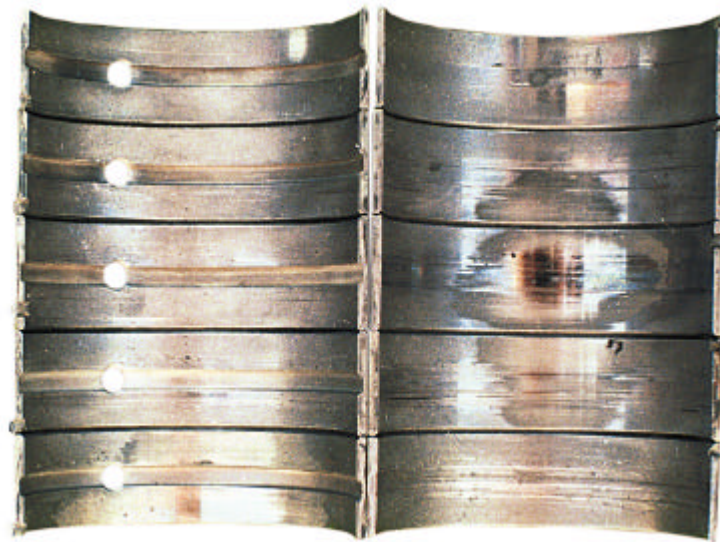
### **MISALIGNMENT OF SHAFT AND HOUSING**

There are a number of causes that give rise to misalignment of the crankshaft and cylinder-block housings, such as improper machining, bent crankshaft, distorted cylinder block, etc. These defects result in localized wear, which tends to be greatest on some of the main bearings and less pronounced on others.

**Recommendation:** ensure that cylinder-block and crankshaft machining tolerances are in accordance with the engine manufacturer's specifications

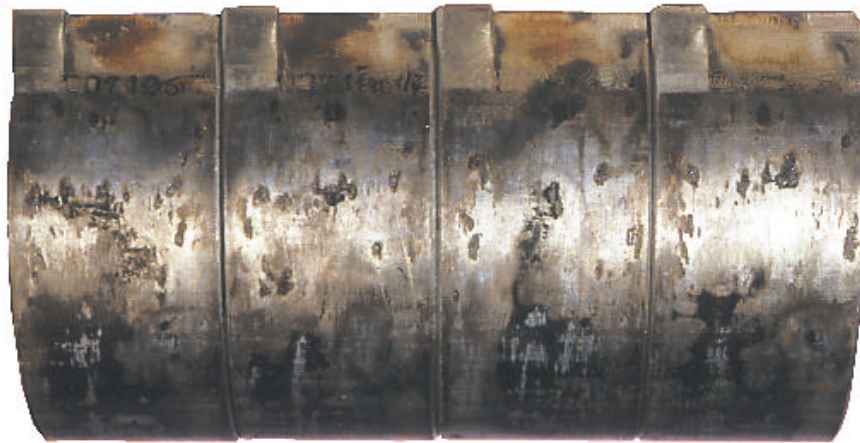
##### **INSUFFICIENT CRUSH**

Total contact between the bearing back and housing is fundamental to ensure good heat transfer and a correct seating of the part. If crush is insufficient, the bearing will move back and forth within the housing and shiny areas will be visible on the bearing back due to friction with the housing. On other occasions, discolorations or stains may appear, evidence of burnt oil that has worked its way into the space between the two surfaces.

**Recommendation:** ensure that the size of the housing bore and torquing are in accordance with the manufacturer's recommendations.

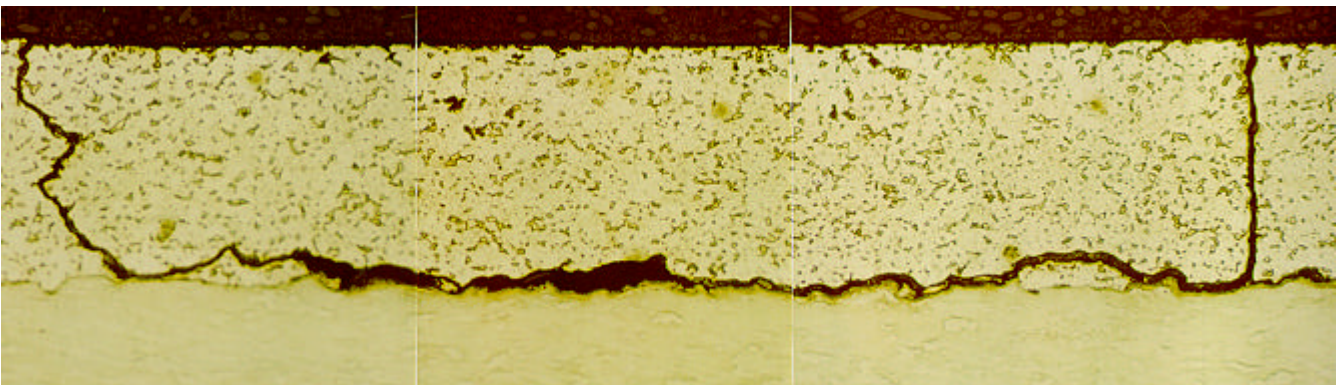
## 5 -- OVERLOADING

Where operating conditions cause excessive load to be exerted upon the bearings, this leads to damage due to metal fatigue

**Recommendation:** check that the assembly clearances and bearing material are as specified for the application in question. Similarly, ensure that engine-tuning conditions are respected

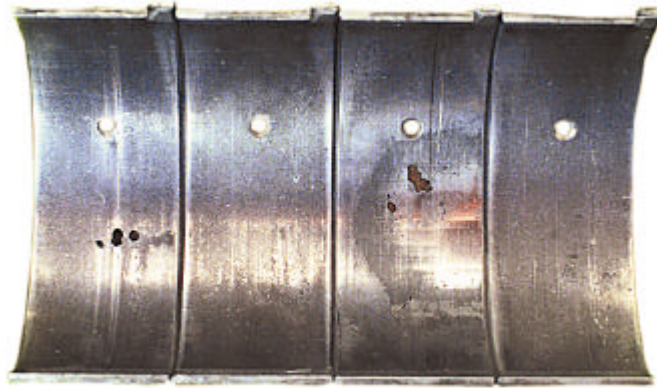
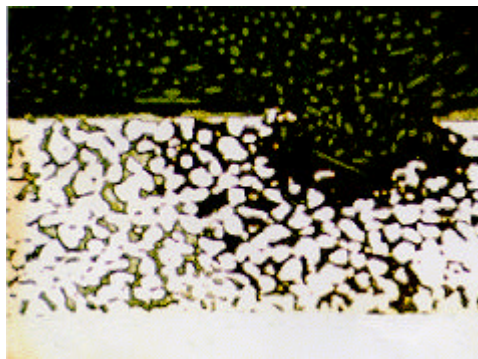
## 6 – CORROSION

Oil in poor condition can damage the bearing surface. This effect is due to dilution of the lead in the alloy by certain of the compounds produced by oil degradation.

**Recommendation:** always use the oil recommended by the manufacturer, and perform the scheduled oil changes as indicated in the vehicle maintenance manual.

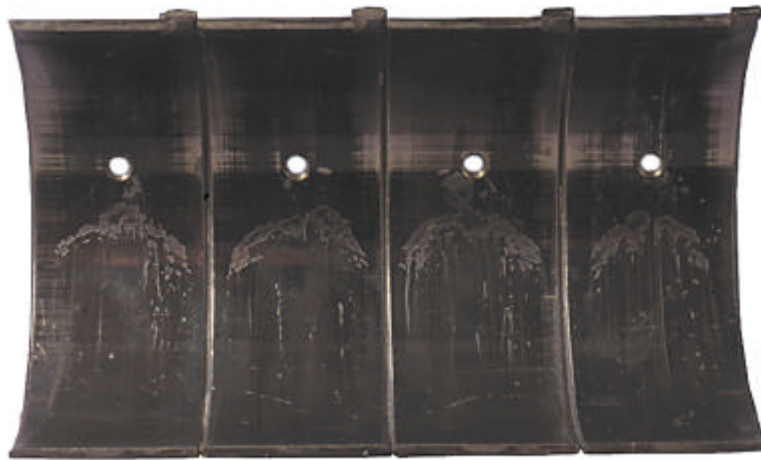
## 7 -- CAVITATION

Under certain operating conditions, oil pressure drops locally, producing vapour bubbles that cause damage to the bearing surface. This damage will be evident in certain bearing areas, such as oil grooves or holes, that are affected by discontinuities in the oil flow.

**Recommendation:** check that lubrication conditions, such as oil pressure, flow rate and type, are as stipulated by the vehicle manufacturer.
