**GMC MOTORHOME REAR SHOCK ABSORBER FAILURE – PASSENGER SIDE (REAR BACK WHEEL)
– SEPTEMBER 2020**

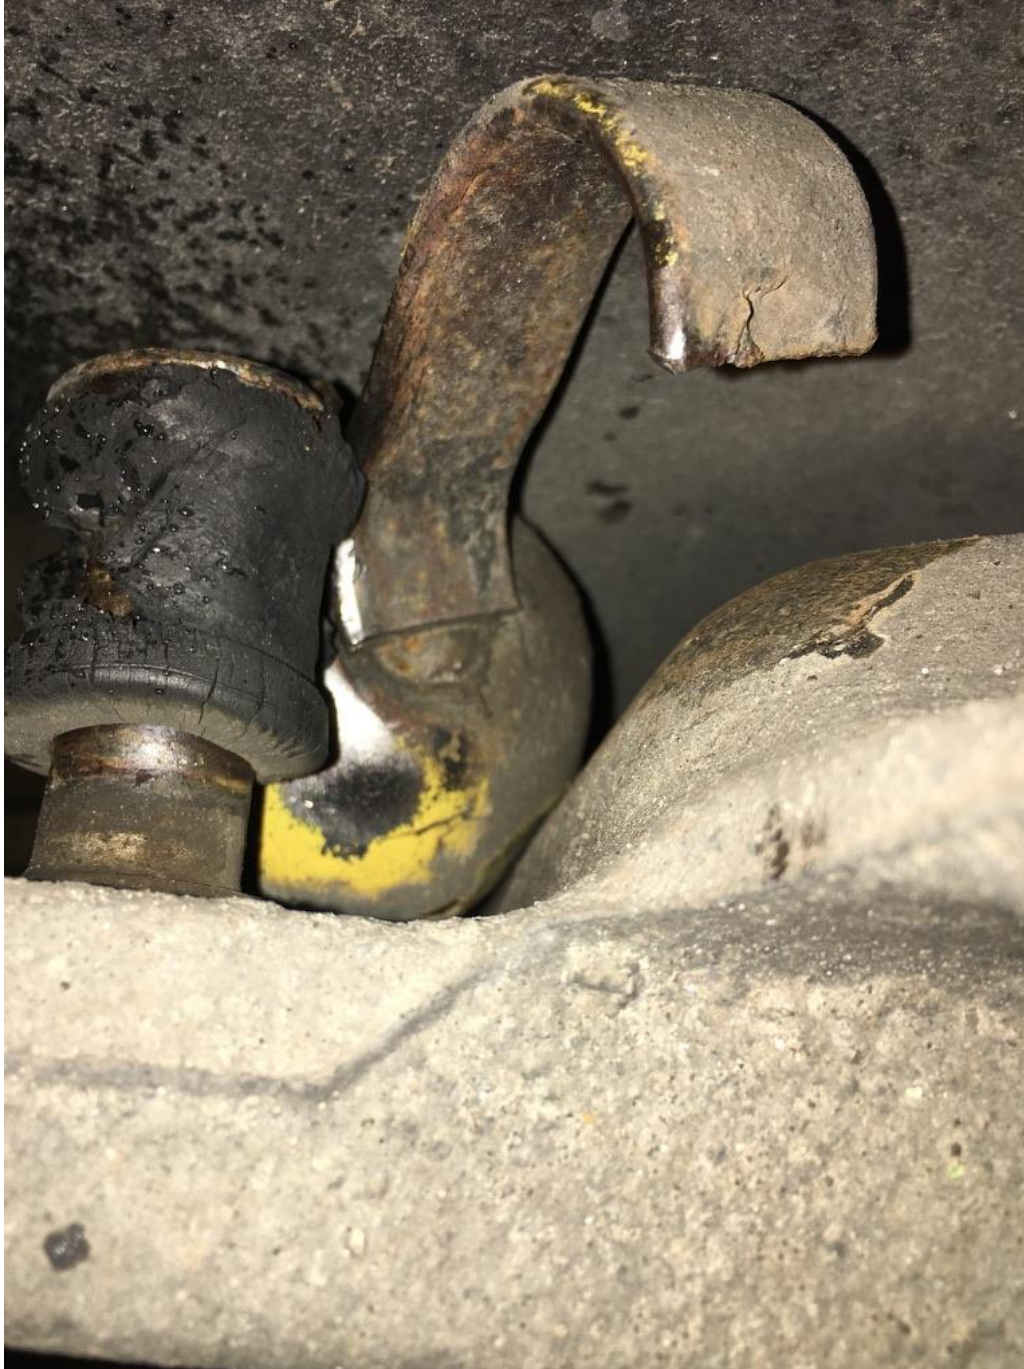
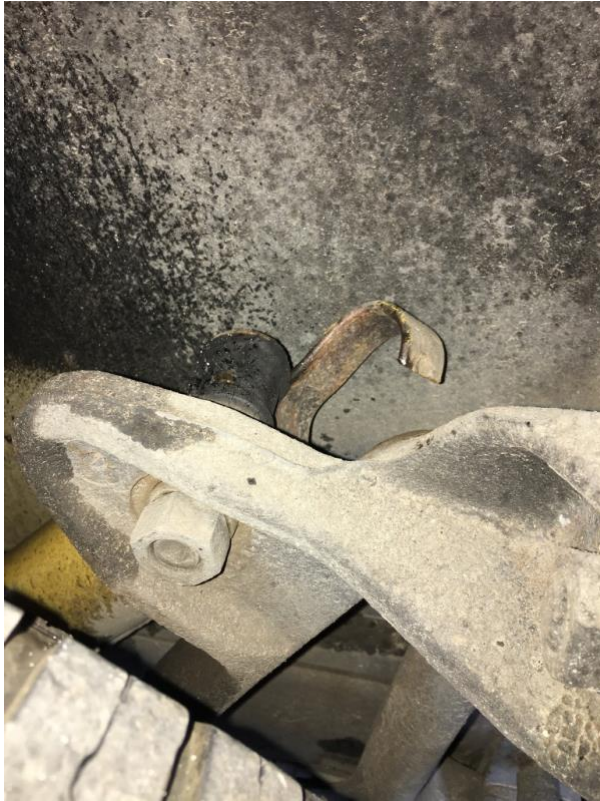
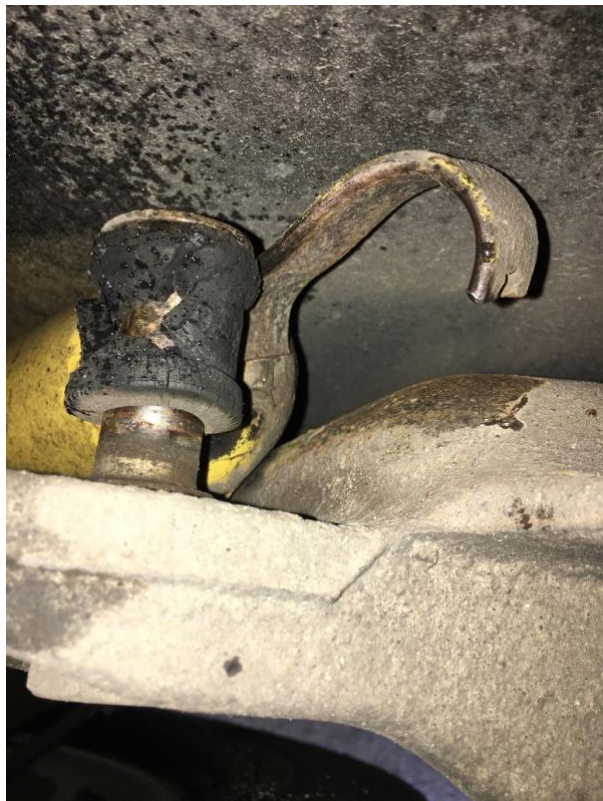
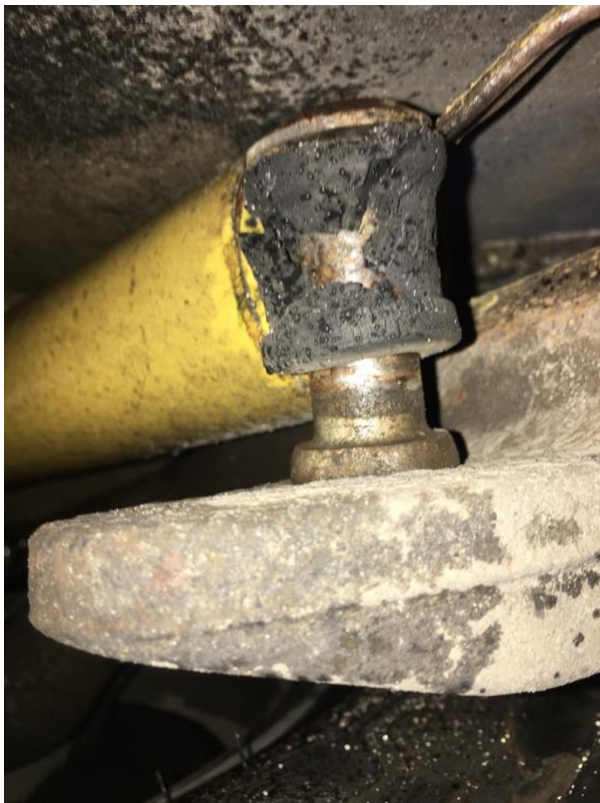
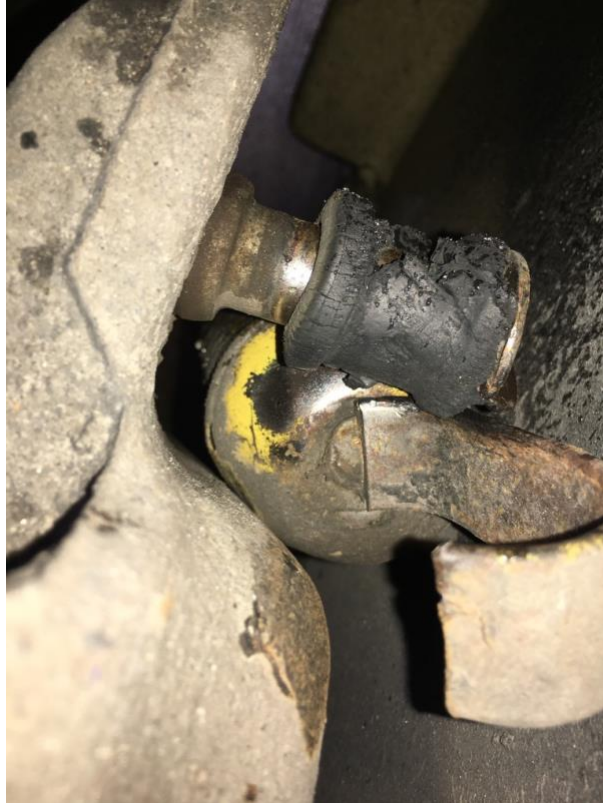
I just happened to look under my passenger side far rear tire and noticed a piece of curved metal about an inch wide sticking up above the tire close to the body behind the control arm and airbag. Only after I took these pictures did I see what happened. The top of the shock absorber was broken. The metal surrounding the bushing had peeled itself back and broken as shown. Interestingly, I did not notice any significant handling issues when driving on a recent trip.

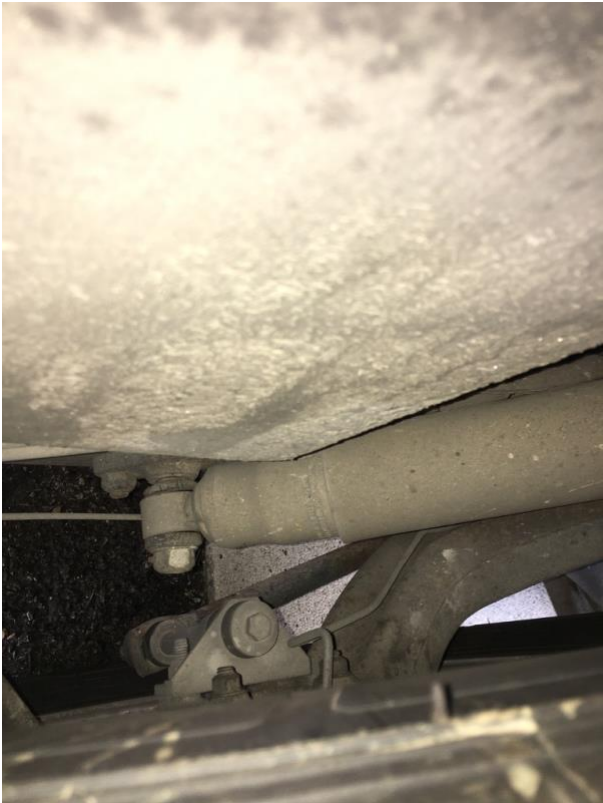
Bottom of Shock bolted to the frame for reference:
